# SITE INVESTIGATION REPORT

### ALABAMA AIR NATIONAL GUARD 187th FIGHTER GROUP

DANNELLY FIELD MUNICIPAL AIRPORT  
MONTGOMERY, ALABAMA

NOVEMBER 1995

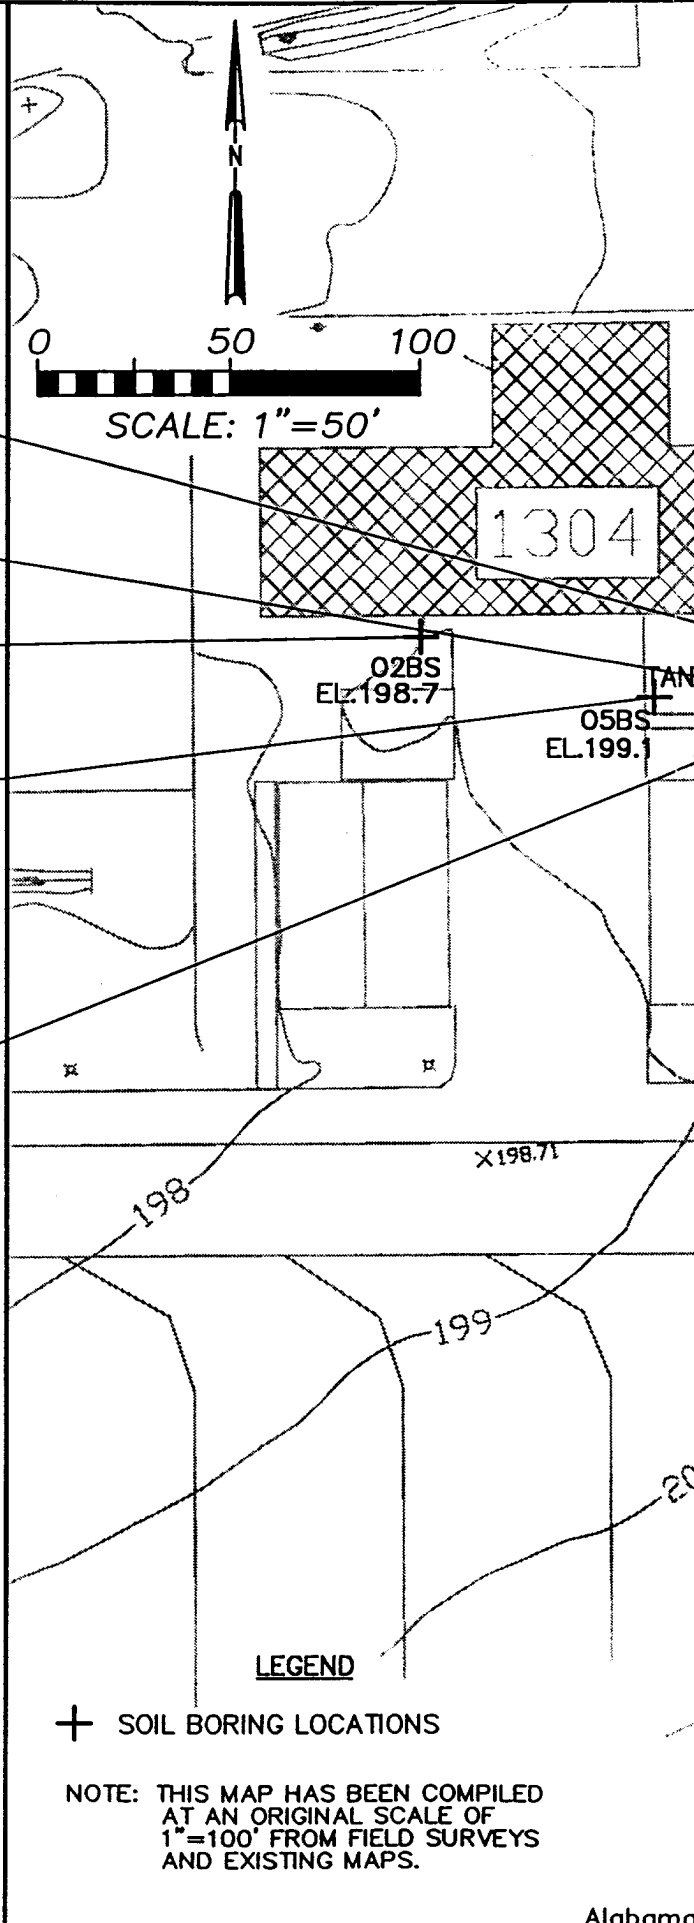
# 01BS

DCA -790[14-16D]	Tol -21000[0-2]
1,2 DCE -5400[6-8]	5300[6-8]
220J[14-16]	310J[14-16]
960[14-16D]	1100[14-16D]
ACE -5000B[0-2]	TCE -33000[14-16]
13000B[6-8]	65000E[14-16D]
4800B[14-16]	Xyl -89000[0-2]
Ben -1000J[0-2]	17000[6-8]
Eth -11000[0-2]	790J[14-16D]
1300J[6-8]	Tete -1100[14-16]
Meth -9500B[0-2]	400J[14-16]
7900B[6-8]	TPH -2120[0-2]
	69.1[6-8]
	37.8[14-16]
